Safety Warning 4/2013 (Published by the ERCA Safety Commission and Dropzone Ltd.)
Collapse of pole top including pole cap and steel cantilevered arm..

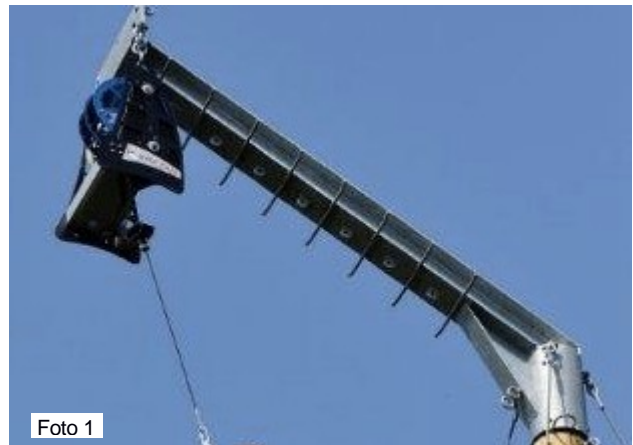
We have received a report of the top of a pole breaking, sending the steel construction (see photo 1) attached to the top of the pole falling to the ground. The steel cantilevered arm was attached to a steel cap over the top of the pole. This steel cantilevered arm was used to hang a 'Powerfan' descending device. The cantilevered steel arm fell to the ground during use. Nobody was injured. The problem appears to lie with the connection between the cantilevered steel arm and the wooden pole, (ie. the support structure) and not with the 'Powerfan' descending device itself.

- The cap is 50cm long, and the steel arm has a length of approximately 3m.
- The cap was attached with four screws around the top of the sleeve and four screws around the bottom of the sleeve.
- The space between the pole and the steel cap was filled with polyurethane foam and sealed with a sealing compound around the bottom edge.

If your ropes course has exactly that type of cantilevered arm as described (and shown) above, or if you are uncertain whether it contains such a structure, we recommend immediately (best before next use) to ensure that there is no problem of rot. Your ropes course constructor or your inspection body can help with clarification (e.g.: Was exactly this checked in the last inspection and when?) and/or provide an expert test.

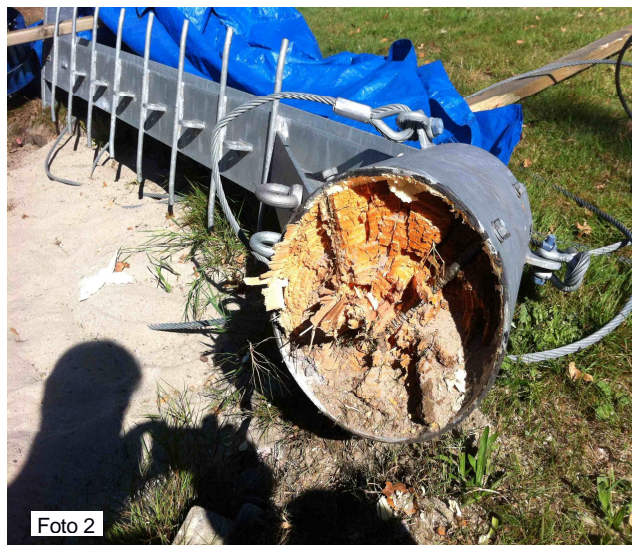
As can be seen clearly in photo 2, the pole broke at the bottom edge of the cap. Following an initial investigation and consultation with structural engineers it appears that widespread rot is one of the main causes of the breakage.

This was one reason why we would remind all that rot can be a problem with severe consequences. So you should focus in particular on such points where wood is covered or located in a closed construction.
